DEPARTMENT OF TRANSPORT

Investigation into the Clapham Junction Railway Accident

Anthony Hidden QC

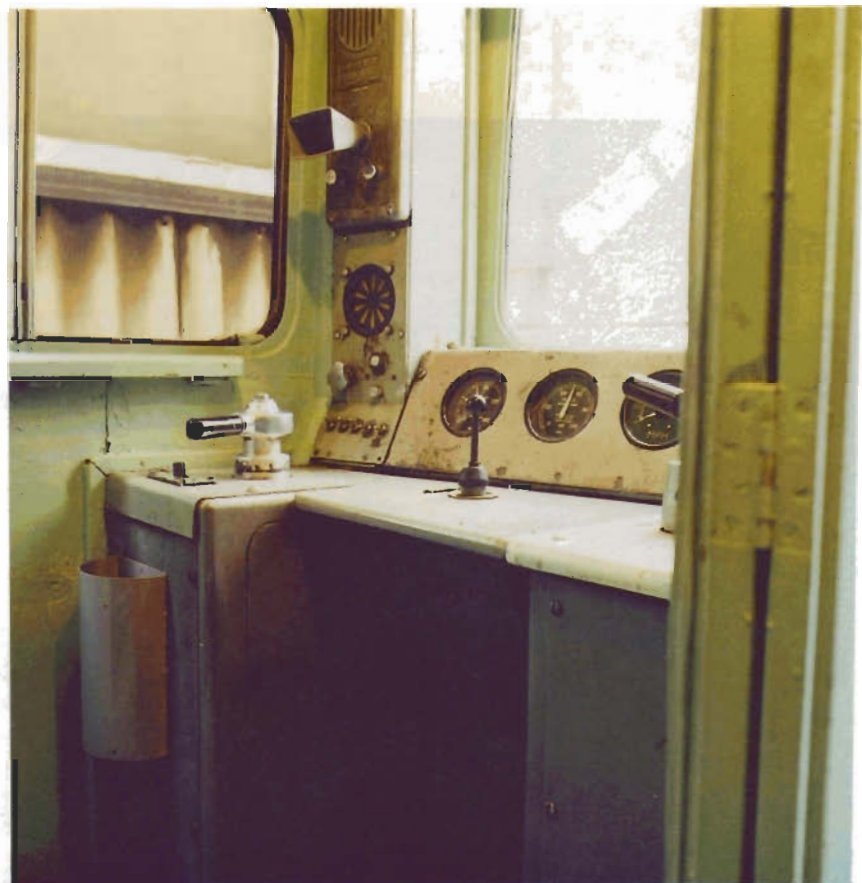
- (i) the horn will stop;
- (ii) it will prevent or cancel the application of the brake which would otherwise happen automatically; and
- (iii) it will cause a visual indicator which normally shows a black disc to display instead yellow spokes (called in railway jargon "the sunflower". This can be clearly seen in Figure 4):

Fig 4. An interior view of a **Driver's Cab** showing the controls.

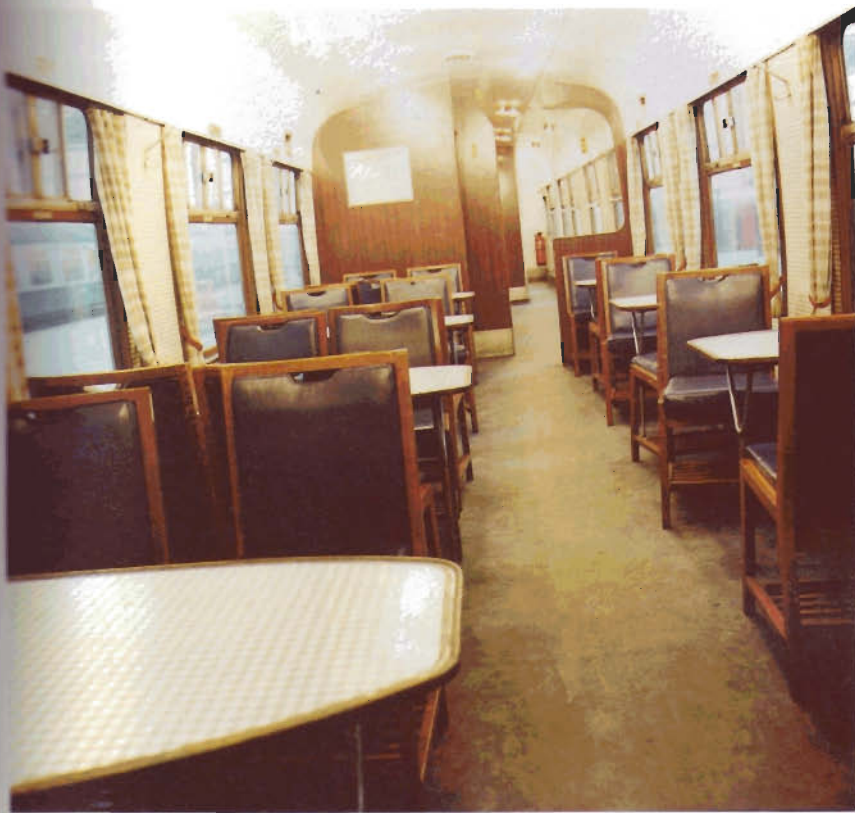
Fig 5. An interior view of the type of Buffet Car on the Poole train, showing the non-fixed seating, facing forward in the direction of travel.

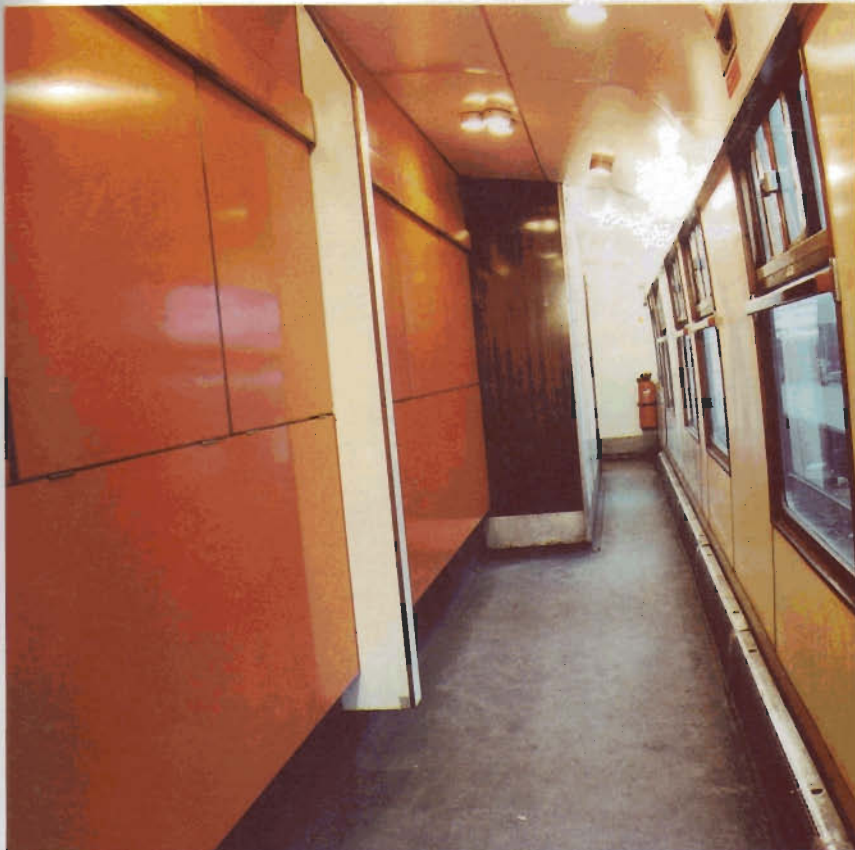
Fig 6. A further interior view of the type of Buffet Car, again facing forward, showing the closed shutters on the left, behind which are the kitchen and serving areas, and the passenger space on the right.

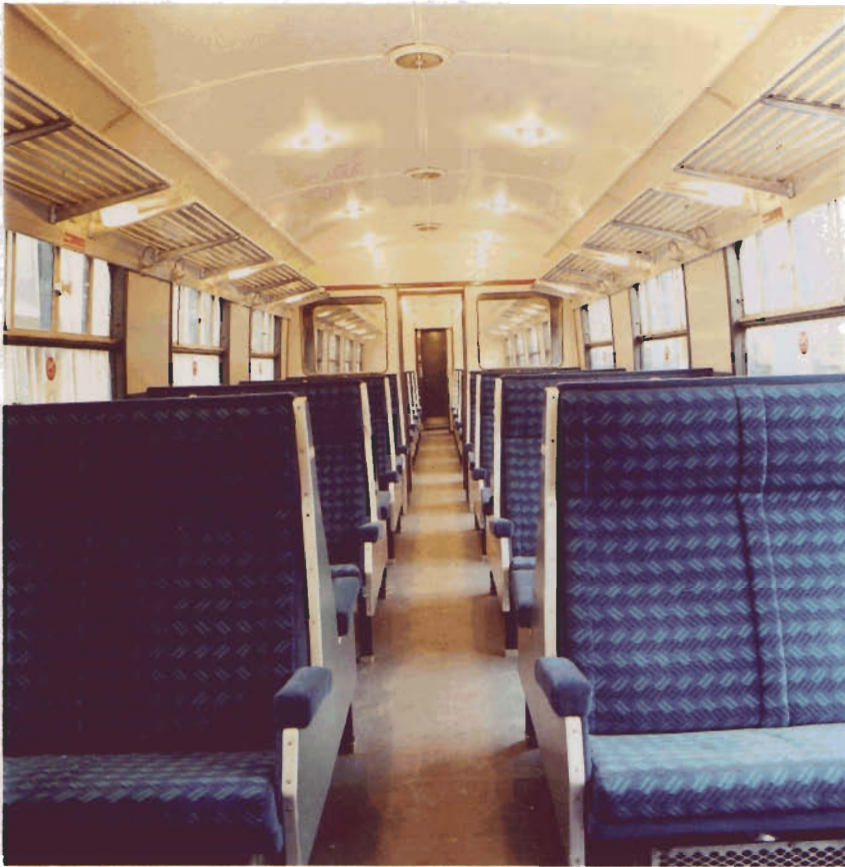
Fig 8. An interior view of Mark 1 rolling stock similar to some carriages of the Poole train, showing lateral luggage racks.

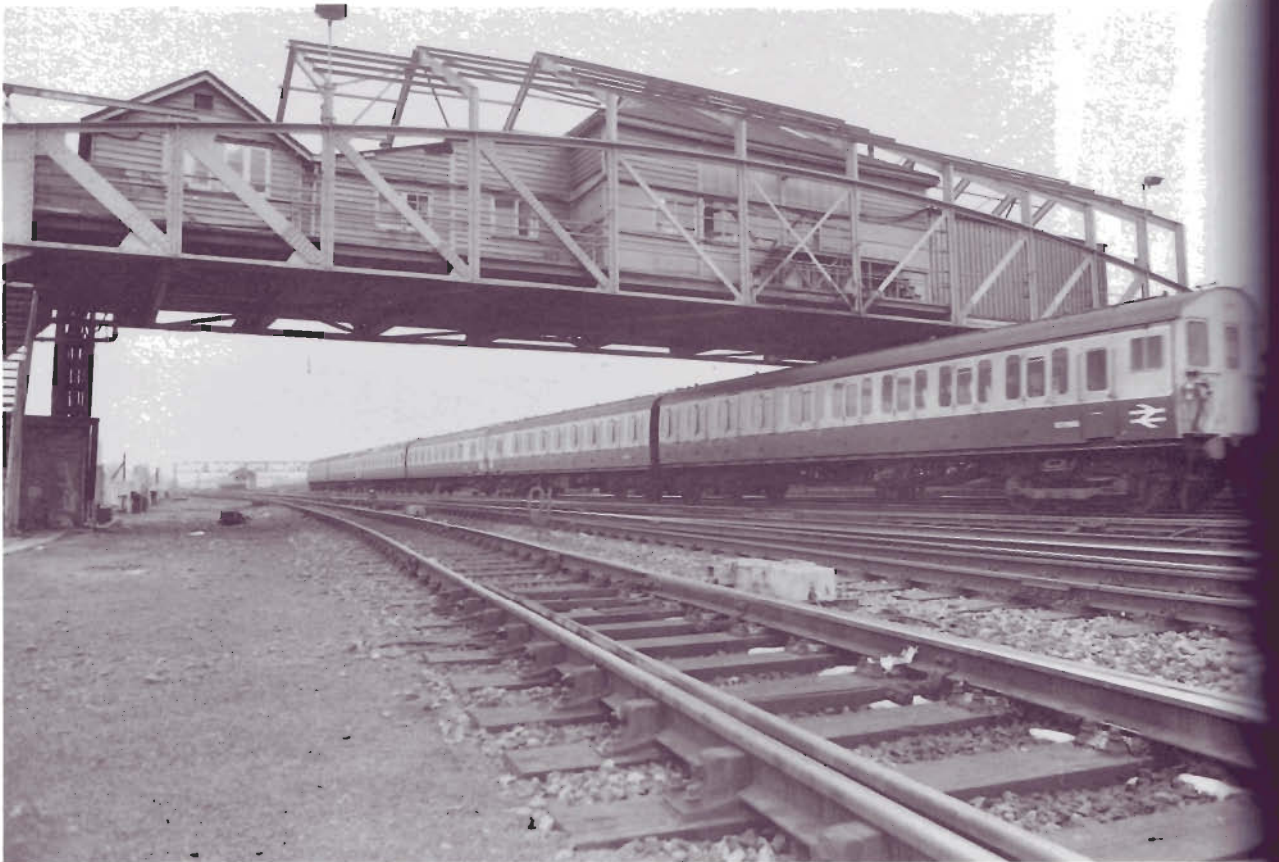
Fig 10. A view of Clapham Junction 'A' Signal Box with the relay room at the extreme right and the first third of the leading coach of the passing train.

7.9 This was certainly the case in relation to Job No. 201. It appeared to the installer, Mr Hemingway, that there was not physically enough room in the relay room for the additional relays for Job No. 201. He therefore worked out a scheme whereby multicore wiring would be run out of the relay room to a room on the far side of the signal box which had once been the lineman's office. From there the wiring would return to make the connection at fuse 107 on row 12 in the relay room. (A general view of the relay room can be seen at Figure 11. It occupies the far end of the Clapham Junction "A" signal box and can be seen at Figure 10).

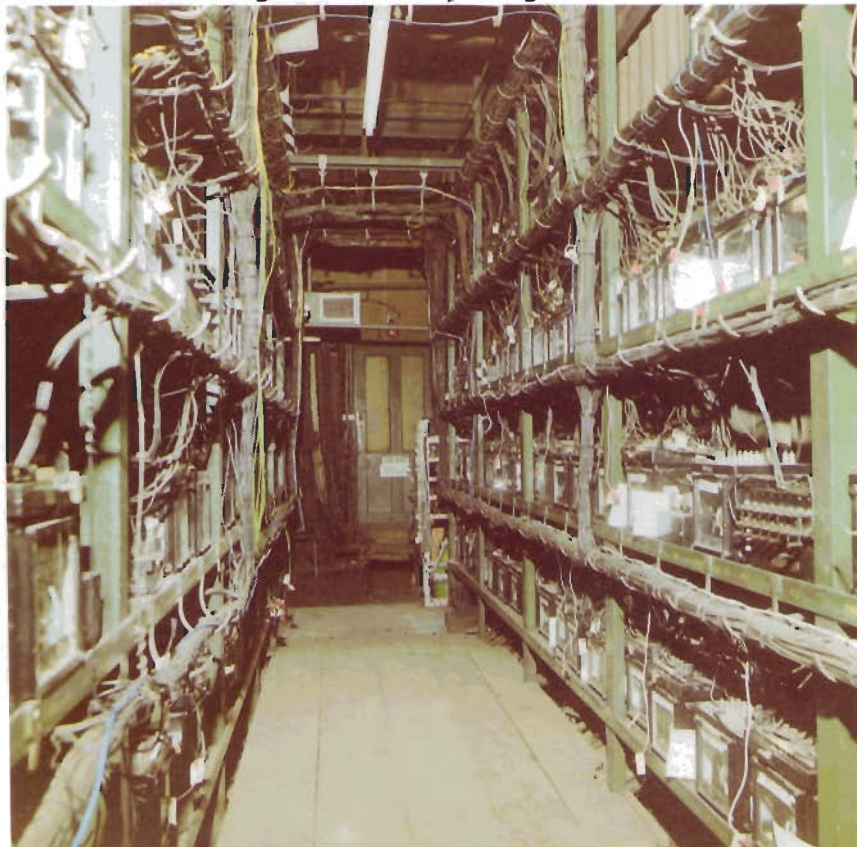
1.16 The relay room at the end of Clapham Junction "A" signal box is only a few yards wide throughout its length (see Figure 11). Whereas the next door Signal Box has good natural light through windows on either side, there is no natural light in the relay room, which is lit by fluorescent lighting from the ceiling. This, while giving enough light for visual observation of the relays and the fuses, presents a rather gloomy appearance and requires additional light for detailed electrical work.

1.17 Inside the door there is a passageway on either side of which are four tiers of wooden racks which carry the many relays upon which the system depends (see Figures 11 and 12). There are six bays of racking on the way to the far end of the relay room and on each shelf in each bay there is room for four relays. These relays are a little larger and heavier than an average car battery and have glass sides so that their physical operation can be visually checked.

Fig 11. A view of the relay room, looking towards the entrance, showing the relay racks, and the trees of the wiring. Relays TRR DM and TRR DN are on the bottom shelf on the right in the last section towards the door.

7.37 The work involved wires which ran from the same “tree” as the wires to TRR DM. (The “trees” are the collection of wires that can be seen running horizontally along the racks and vertically along the upright divisions in Figure 11). The work also involved physical manhandling of the relays themselves. The work had the unforeseen and unwanted result of disturbing the wires in the vicinity of TRR DM. The most unwanted effect of all was to permit the bare uninsulated end of the old “black” wire, left in that condition by Mr Hemingway two weeks before, to revert to the natural position it had held over many years. It went back to lie against and in contact with the terminal which had been its previous home under the old system when it had been designed to pass current to fuse 107. It was still connected to that fuse and now it could and did again pass current directly to it, and out of the relay room down to the signal WF138.

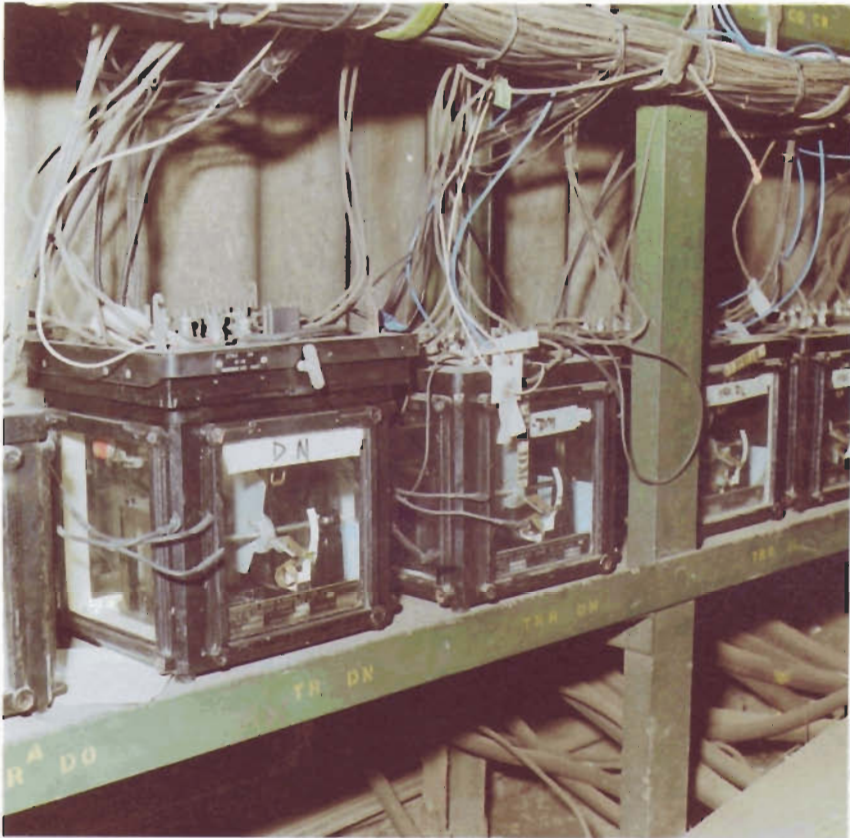
Fig 12. Relays in Clapham Junction 'A' relay room, showing track relay 'DN' adjacent to track repeater relay 'DM'.

7.36 On Sunday, 11 December, further work came to be done in that relay room which had nothing to do with Job Nos. 104 and 201. However, by a coincidence that was to be catastrophic the job involved work in the immediate vicinity of the relay TRR DM. The task was to replace the adjoining relay TR DN with another unit. These relays are a little larger and heavier than a conventional car battery. They can be seen in Figure 12, TR DN being to the immediate left of TRR DM. This work involved not only the movement of individual wires in their transfer to the new relay, but also the physical movement of the old and new relays themselves. The existing relay was pushed bodily towards the back of the shelf and the detachable top of the new relay was placed on a convenient piece of wood at the front of the shelf. Once the wiring work was completed the old relay was moved out and the new relay moved into its place. It was again pure coincidence that it was Mr Hemingway who had to do this work: this time his assistant was not Mr Dowd.

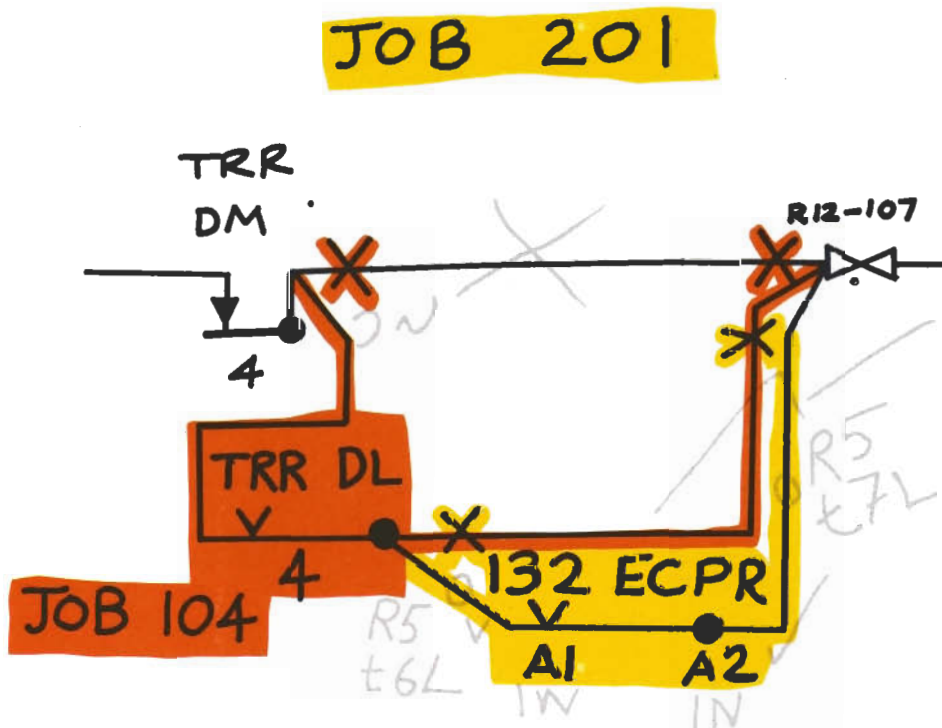
Extract from Design Office Working Diagram for Jobs 104 and 201, showing Mr Hemingway's Pencil Additions.

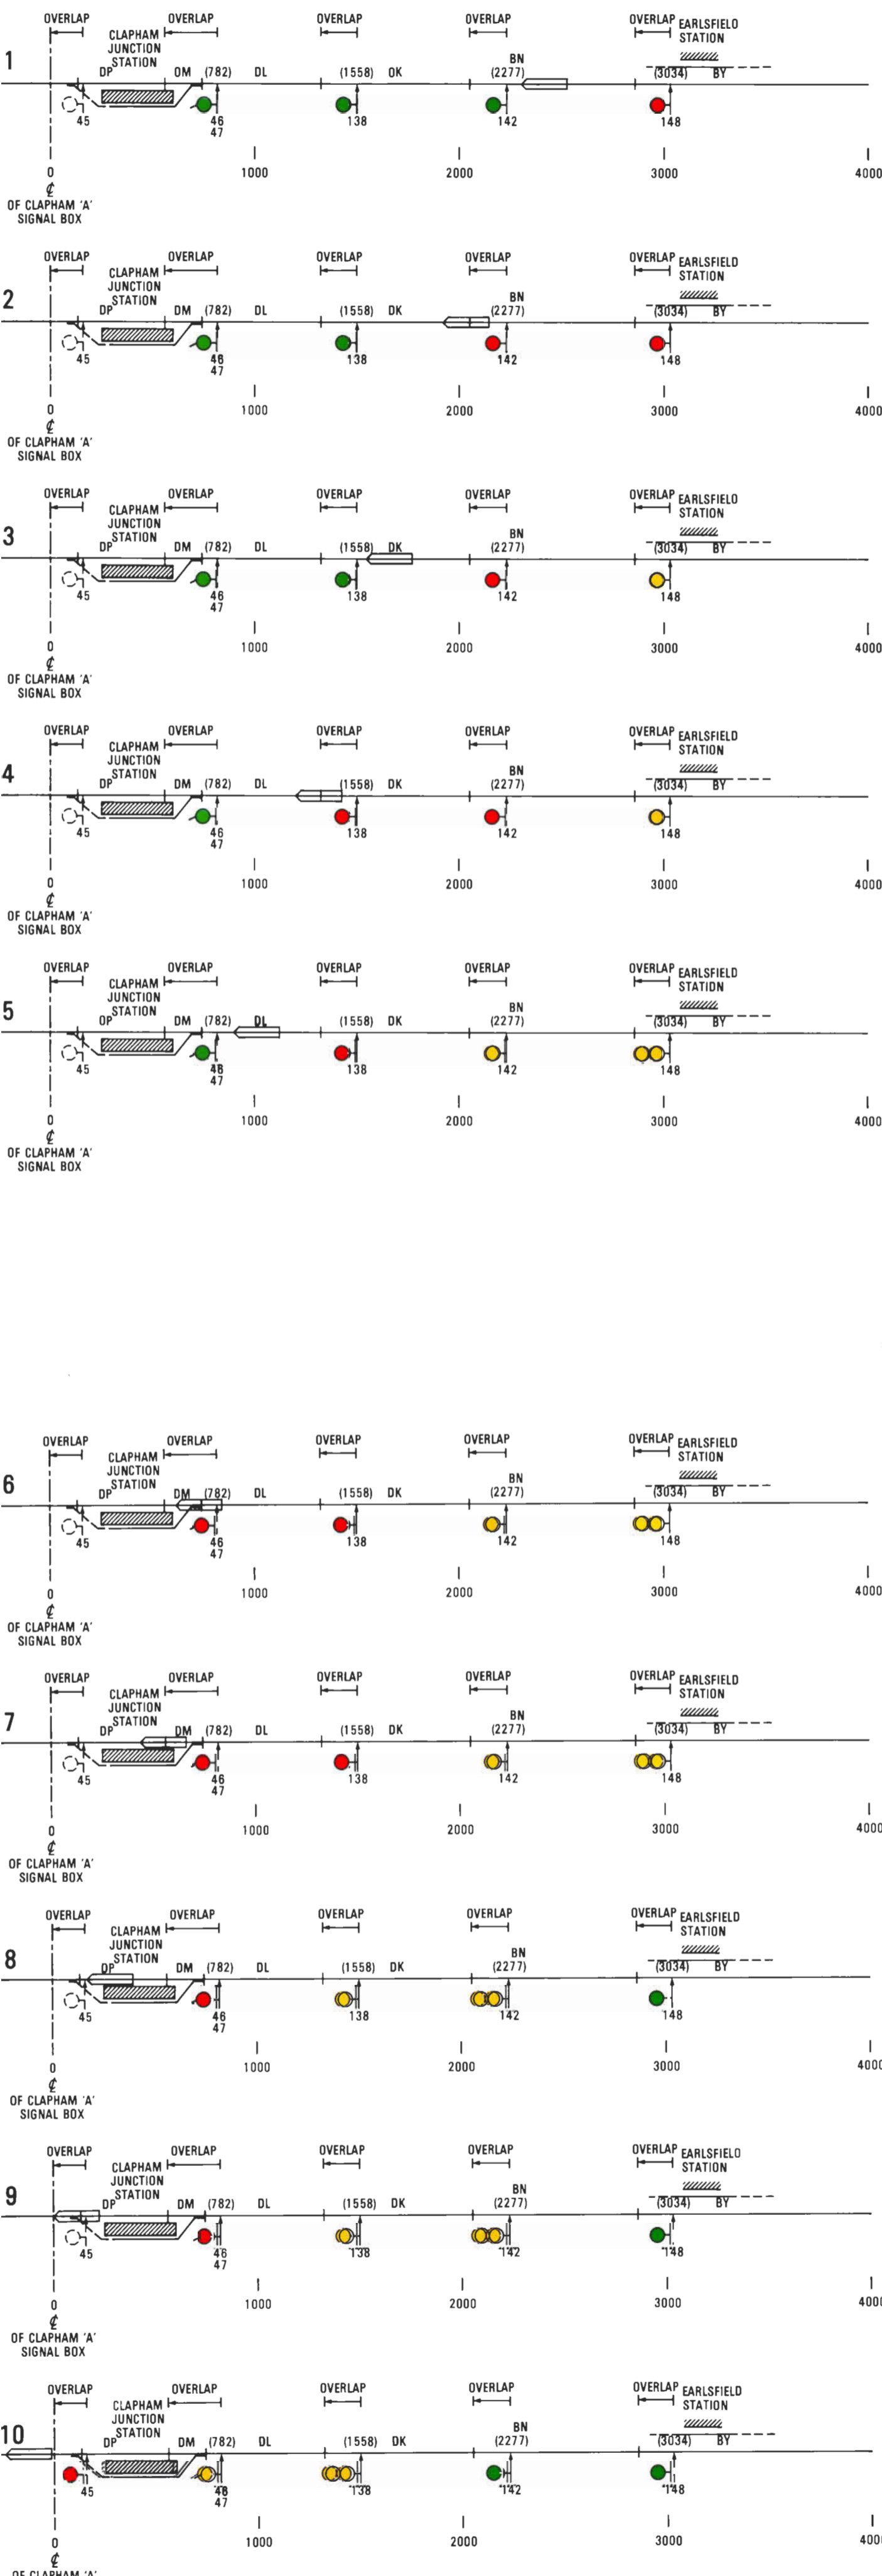
(B) ASPECT SEQUENCE OF SIGNALS WITH ONE TRAIN PASSING SHOWING EFFECT OF WIRING ERROR

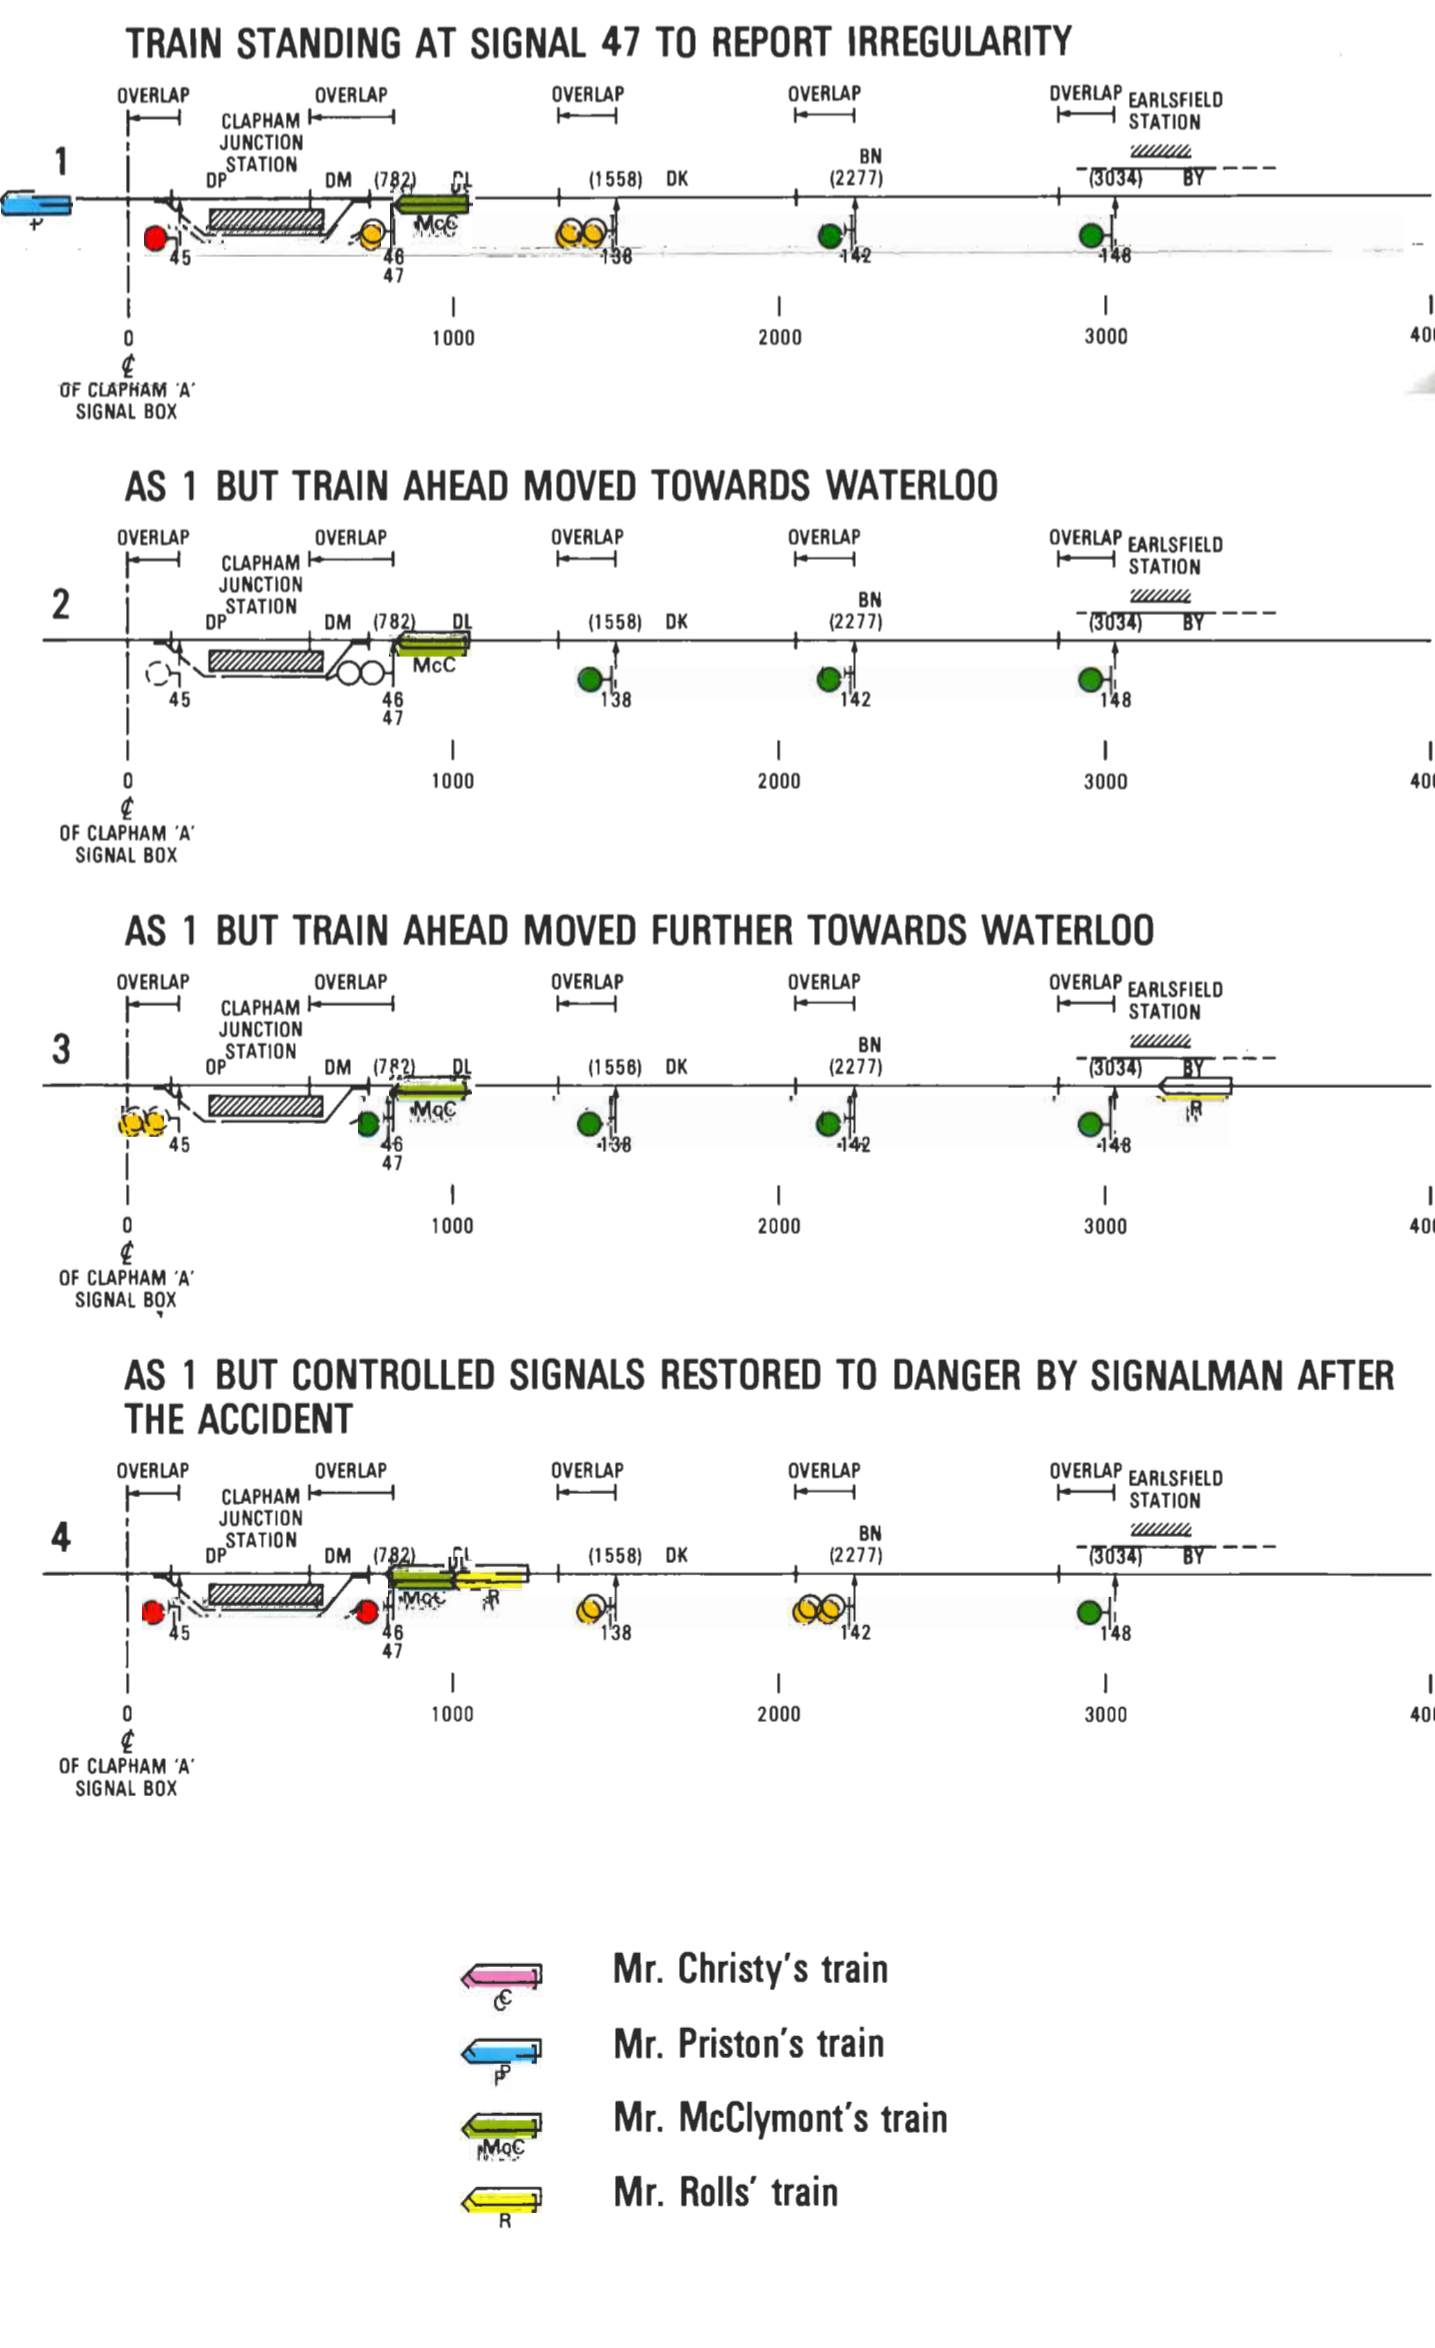
(D) ASPECT SEQUENCE OF SIGNALS IMMEDIATELY BEFORE AND AFTER THE ACCIDENT
